Oversight Summary	Site Name	Pohatcong OU-3 PVGCS OU3
		Location	Washington, NJ

Oversight Personnel	Role	Agency	Coverage Hours	Date/Day/Weather
Patrick Nejand	PRP Oversight	USACE - NYD on Behalf of USEPA	07:00-17:30	12/22/19 / Sunday / 25-45F Partly Cloudy, southwest wind 8mph

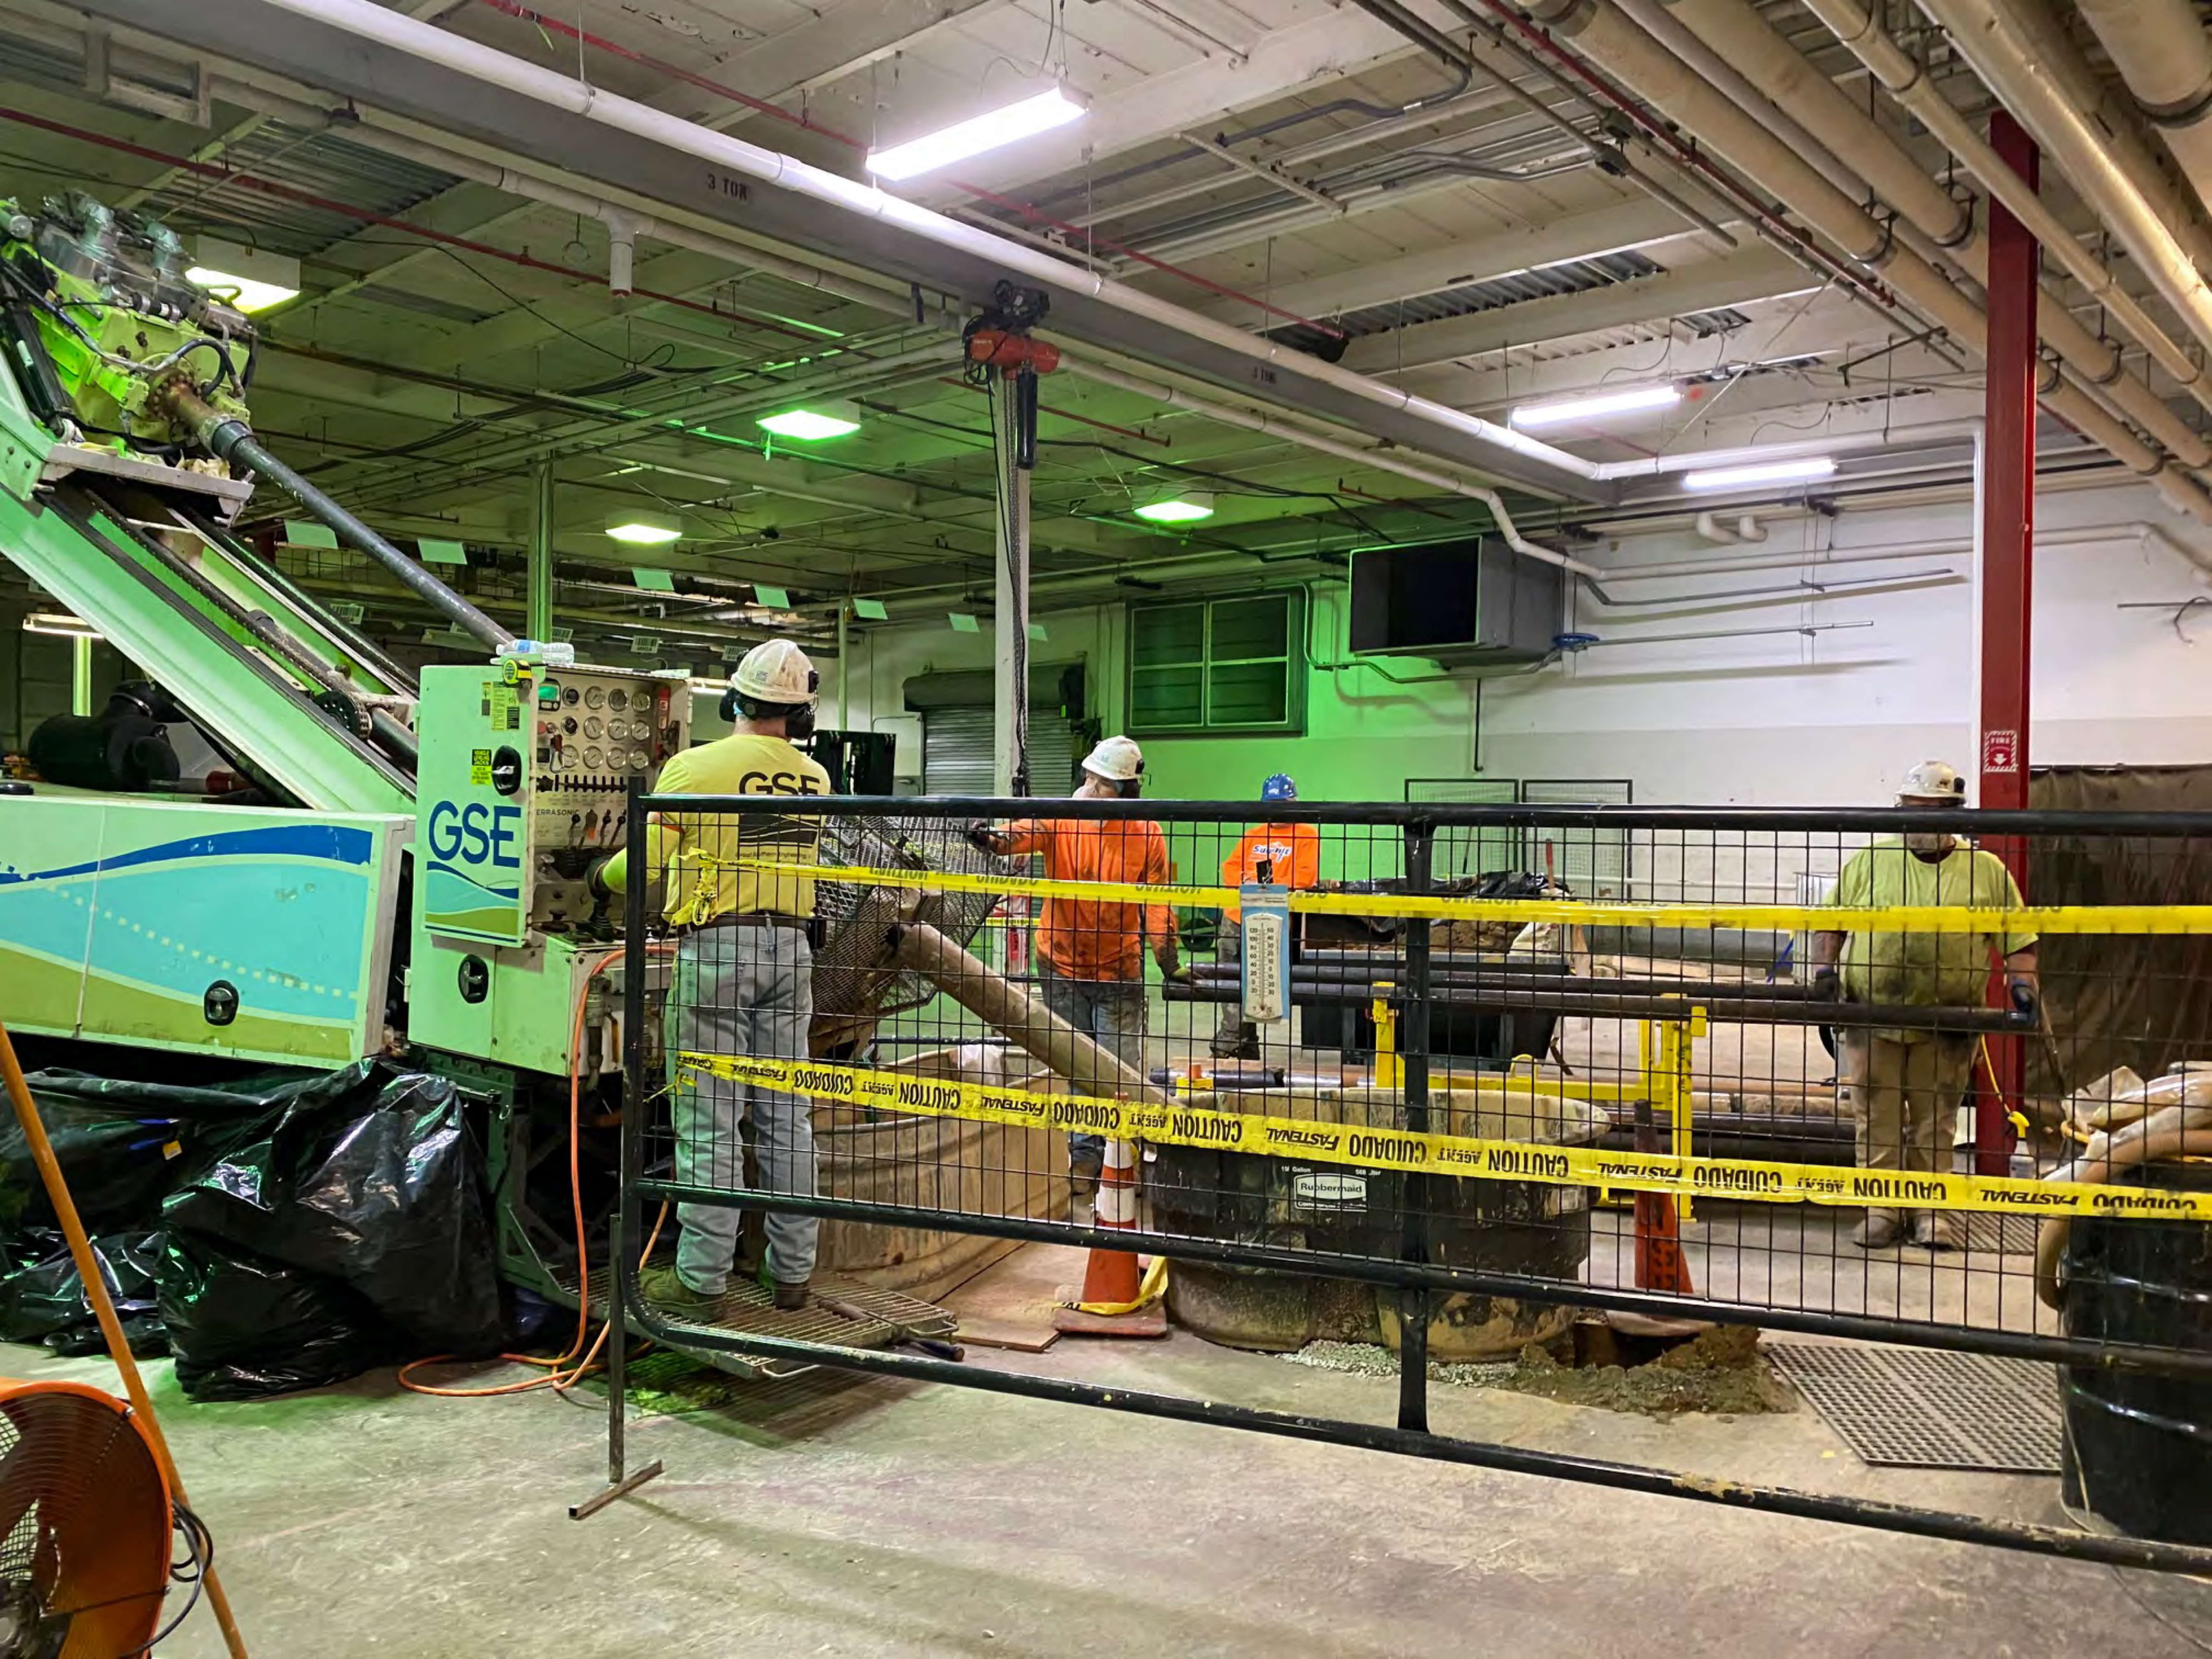
GSE continued drilling at HF8-9. They have placed approximately 90' of 6 inch casing. At approximately 10:20 Hours noted to Ramboll seepage of drilling fluid approximately 25' away from the zone in mechanics room. TRS vacuumed the drilling fluid via a shop vac with Ramboll monitoring. Some of drilling rig water/material may have traveled underneath the building floor slab and seeped out in concrete cracks approximately 25+ away from the rig at HF8-9 at a location identified as the plant mechanics room (not in drilling work area). Apparently, according to Ramboll the water used for placement of 6 inch casing is not absorbing in the bottom of drilling hole or not coming up horizontally directly to the containment tub due to possibly silt clay layer and/or seal of the hole. According to Ramboll the material is using the path of preferential flows to travel underneath the slab to traverse into other areas and coming out in plant concrete crack/seams. Based on several adjustments, including modification of operation of the drill rig and removal of bentonite seal by the drilling location, by noon the issue was resolved for today. Ramboll to provide a summary in their reports. Ramboll noted that there are no safety or air monitoring issue with the material seeping into the plant work areas. TRS cleaned the area affected.
